# Troubleshooting LONWORKS® Devices and Twisted Pair Networks

# [2.] Troubleshooting Strategy Flowchart

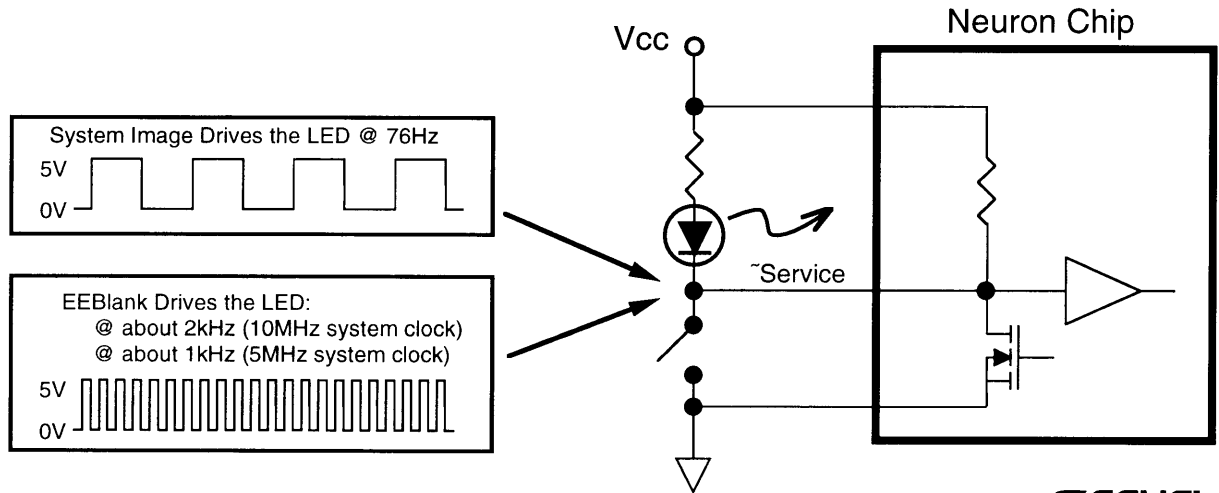
### [4.4.1 ] Service Pin Drive Waveforms<sup>1</sup>

- Service Pin is used to drive the Service LED & to read the Service Switch state:
  - LED Off:** -Service = 5V
  - LED On:** -Service = square wave drive waveform (see below)
  - Service Switch Pressed:** -Service = Ground

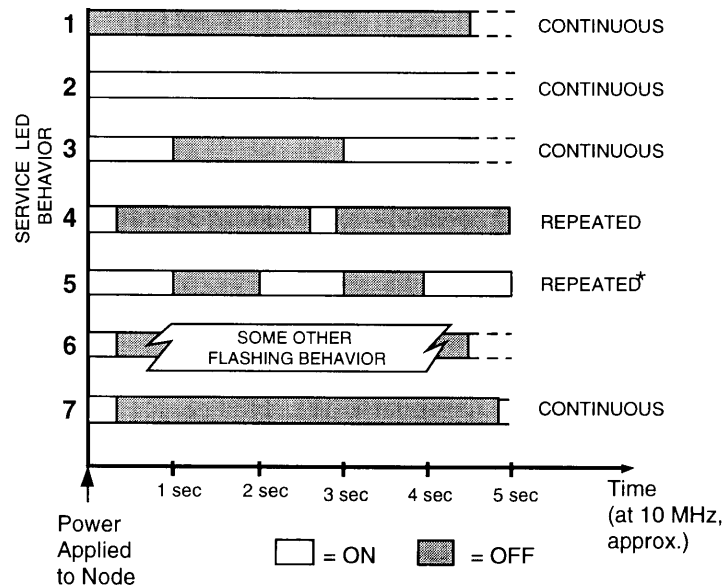
### [4.4.2] Service LED Flashing Behaviors<sup>11</sup>

- (See the next slide for an explanation of these flashing behaviors)

Flashing Behavior & Context	Likely Explanation
1: LED is OFF continuously as soon as power is applied to device.	<ul style="list-style-type: none"> <li>•Bad device hardware. Suspect power supply problems [4.8.4], clock problems [4.9], or a bad Neuron Chip.</li> </ul>

2: LED is ON continuously, even when power is first applied to the device.	<ul style="list-style-type: none"> <li>•Bad device hardware. Suspect power supply problems [4.8.4], clock problems [4.9] or a bad Neuron Chip. For a 3150 Chip device, also check for a short between pin 17 (-Service) and pin 18 (Do Not Connect). Pin 18 is an output that toggles during execution, and this fault can cause a continuous stream of Service Pin packets to be sent.</li> </ul>

3: LED flashes at power-up, goes OFF, then comes ON solid.	<ul style="list-style-type: none"> <li>•This is the normal behavior for an Applicationless device [4.3]. If the device is not supposed to be Applicationless, suspect a checksum error caused by LVI problems [4.8.1], memory problems [5.2], PCB layout problems [5.4], or application code errors. A self-test failure can also turn the LED ON solid.</li> </ul>

5: LED blinks ON & OFF at 1/2Hz rate,	<ul style="list-style-type: none"> <li>•This is the normal behavior for an Unconfigured device [4.3]. If the device is not supposed to be Unconfigured, suspect a checksum error caused by LVI problems [4.8.1], memory problems [5.2], PCB layout problems [5.4], or application code errors.</li> </ul>

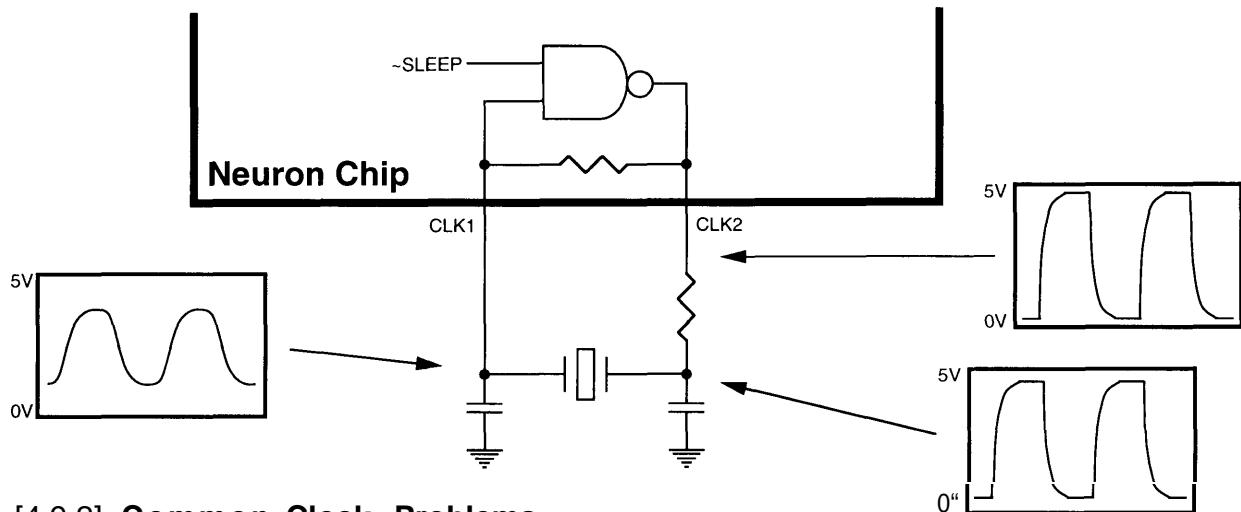
### [4.9.1] Clock Circuit Waveforms<sup>1</sup> (when measured with a Z-lead oscilloscope probe)

SYMPTOM	POSSIBLE CAUSE
Clock waveform is the wrong frequency	<ul style="list-style-type: none"> <li>•Crystal is the wrong frequency</li> <li>•Capacitors are the wrong value. NPO caps are recommended here for temperature stability.</li> <li>•CLK2 is overloaded with other gates (one HC input allowed)</li> <li>•A digital oscilloscope measuring the waveform could be aliasing. Change the time base a few steps to see if the frequency looks correct at a different time/div.</li> </ul>
Clock signals are stuck: CLK1 = 5V, CLK2 = 5V	<ul style="list-style-type: none"> <li>•Neuron Chip may be asleep. Press the Service Pin or Reset to force a wakeup.</li> <li>•CLK2 output may be shorted to 5V. The Neuron Chip may get hot from a short on its output line.</li> <li>•Neuron Chip may be broken.</li> </ul>
Clock signals are stuck: CLK1 = 0V, CLK2 = 0V	<ul style="list-style-type: none"> <li>•CLK2 output may be shorted to 0V. The Neuron Chip may get hot from a short on its output line.</li> <li>•Neuron Chip may be broken.</li> </ul>

Clock signals are stuck: CLK1 = 5V, CLK2 = 0V	<ul style="list-style-type: none"> <li>•CLK1 may be shorted to 5V.</li> <li>•Neuron Chip may be broken.</li> </ul>
Clock signals are stuck: CLK1 = 0V, CLK2 = 5V	<ul style="list-style-type: none"> <li>•CLK1 may be shorted to 0V.</li> <li>•Neuron Chip may be broken.</li> </ul>
Clock signals are stuck: CLK1 = 2.5V, CLK2 = 2.5V	<ul style="list-style-type: none"> <li>•Crystal or resistor may be open.</li> <li>•(Neuron Chip is probably okay; the 2.5V bias is correct)</li> </ul>
Excessive ringing on clock lines	<ul style="list-style-type: none"> <li>•Non-Z-lead scope probe will show ringing in the waveform.</li> <li>•Clock lines too long. If clocks are being buffered &amp; routed around the PCB, suspect a bad termination. Note that HC gates generally do not work well for transmission lines.</li> </ul>
Neuron Chip operation is intermittent when using a clock oscillator for CLK1, but is fine when using the crystal circuit above	<ul style="list-style-type: none"> <li>•The clock oscillator must have CMOS-compatible output drive levels ("rail-to-rail"). If an oscillator with TTL output levels is used, clock operation may be very intermittent.</li> </ul>

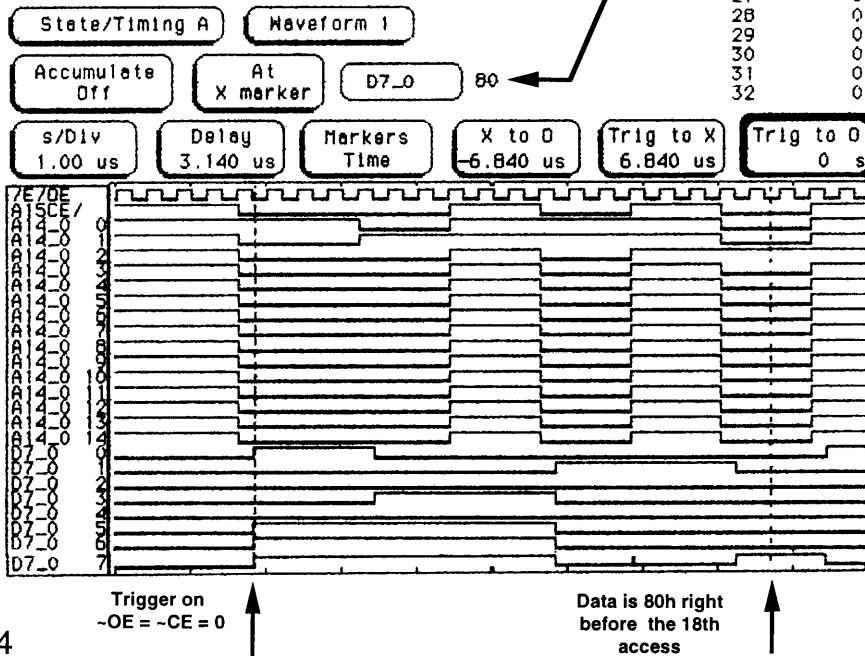
**Logic Analyzer Timing Trace**

Label>	/E/OE	A15CE/	A14_0	D7_0
Base>	Binary	Binary	Hex	Hex
1	0	0	0001	E1
2	0	0	0001	E1
3	0	0	0001	E1
4	0	0	0002	E8
5	0	0	0002	E8
6	0	0	0002	E8
7	0	1	7FFF	E8
8	0	1	7FFF	E8
9	0	1	7FFF	E8
10	0	0	0003	02
11	0	0	0003	02
12	0	0	0003	02
13	0	1	7FFF	02
14	0	1	7FFF	02
15	0	1	7FFF	02
16	0	0	0004	80
17	0	0	0004	80
18	0	0	0004	80
19	0	1	7FFF	01
20	0	1	7FFF	01
21	0	1	7FFF	01
22	0	1	6803	00
23	0	1	6803	00
24	0	1	6803	00
25	0	1	7FFF	00
26	0	1	7FFF	00
27	0	1	7FFF	00
28	0	0	0005	B4
29	0	0	0005	B4
30	0	0	0005	B4
31	0	1	7FFF	02
32	0	1	7FFF	02

- After EEBlank is running correctly [5.2.3], a PROM containing the standard Neuron Chip Firmware (“System Image”) can be checked. The logic analyzer State Listing and Timing Trace shown below are for a 16KB System Image PROM running on an FTT-10 Control Module. The PROM was built for a Neuron 3150 Chip using LonBuilder 3.0 and Version 6 firmware.
- Once the System Image appears to be working correctly, the logic analyzer can be used to check the operation of any other external memory on the device.
- Note that a Bug Katcher™ socket adapter from Emulation Technology was used to allow the logic analyzer to monitor these PROM signals. For the 32-pin PLCC PROM socket on Echelon’s FTT-1 O Control Module, use Bug Katcher part number BC4-32-PCC7-0000. Emulation Technology can be reached at (408) 982-0660.

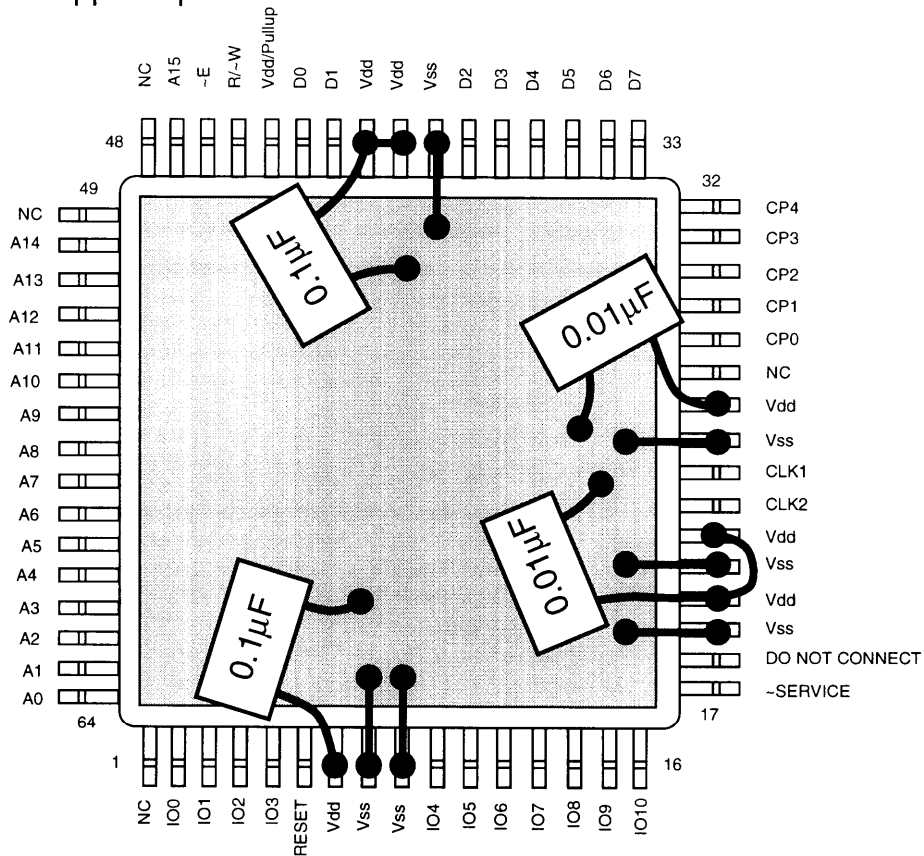
NEURON 3150 CHIP

- **Extremely Effective Technique for EMI & ESD Debugging**  
(especially for PC boards where grounding and decoupling are suspected causes of Neuron Chip errors or latchups)

- 2) Using thin wire (i.e. bare wire-wrap wire), connect each Vss pin to the top hat ground plane. Keep the wire connections as short as possible.
  - 3) Connect four 0.1μF (or 0.01μF) ceramic radial caps as shown between the Vdd pins and the top hat ground plane. Keep all leads short.

- 4) If the PCB grounding to external memory devices is not low impedance, perform the same kind of top hat rework on the memory devices, and connect the top hat ground planes with a **0.5”** wide strip of copper tape.

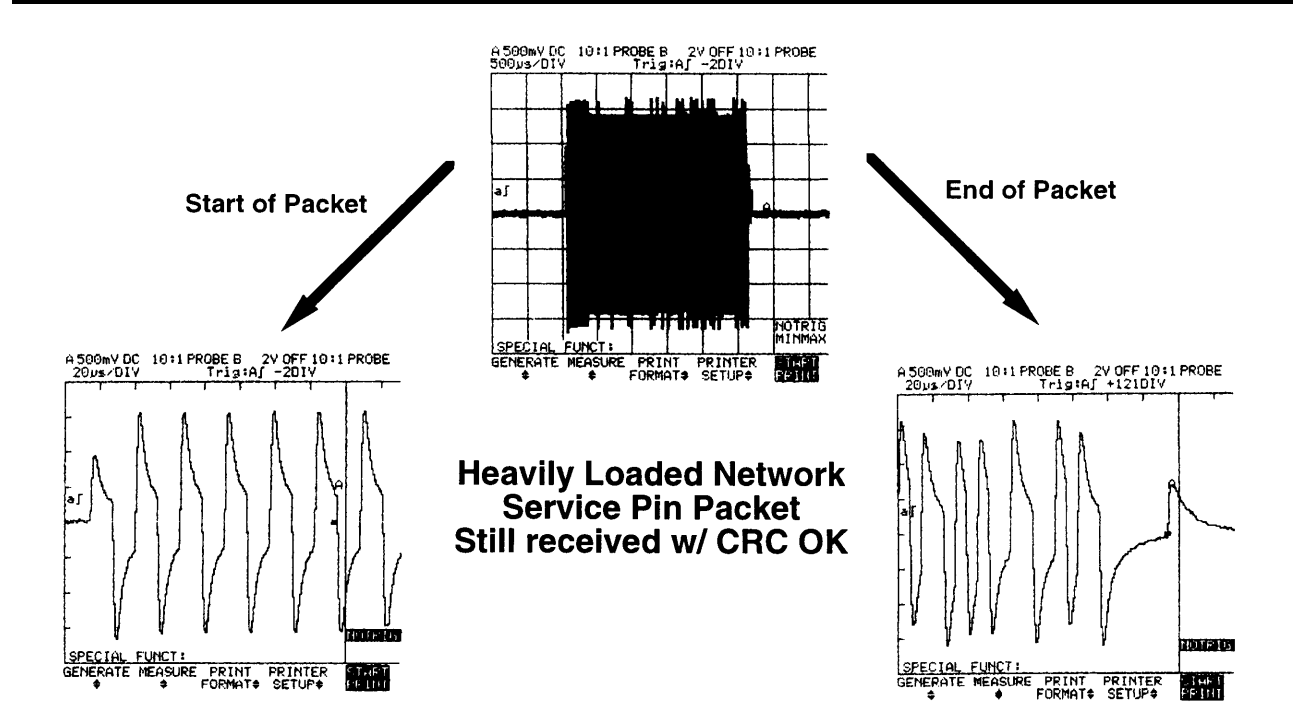
### [6.4.2] Typical TP/XF-78 Analog Network Waveforms

- TP/XF-78 networks must be wired in **Doubly-Terminated Bus topology**.
- See the TPT User's Guide<sup>6</sup> for detailed information.

SYMPTOM	POSSIBLE CAUSE
<p>A device cannot communicate on a TP/XF-78 network.</p>	<ul style="list-style-type: none"> <li>• Use the right-hand side of the Troubleshooting Flowchart shown in [2.] to help in debugging this device's comm problem. First double-check that the wire, connections and termination are correct. Then use Service Pin presses to generate transmit packets, so that the CP line waveforms can be checked [6.1.1]. Another device on the network can be used to generate incoming traffic to the device under test in order to check the CP line waveforms in receive mode. Finally, the analog waveforms on the network can be checked for clues about the lost communication.</li> </ul>
<p>A device can communicate on a small network, but not on a large, heavily loaded network.</p>	<ul style="list-style-type: none"> <li>• Suspect the presence of extra capacitance in the transceiver area, or noise sources on the PC board. Check to be sure that no extra capacitance has been added to the network connection for the device (such as extra transient protection devices like zener diodes). Check also that the PC board layout for the CP lines is low-capacitance (short traces without an adjacent inner-layer ground plane under the traces), Look for noise sources in the 78kbps communication band, like DC-DC converters. If a DC-DC converter is suspected of coupling noise into the transceiver transformer, try re-orienting or moving the inductor to see if communication integrity improves.</li> </ul>

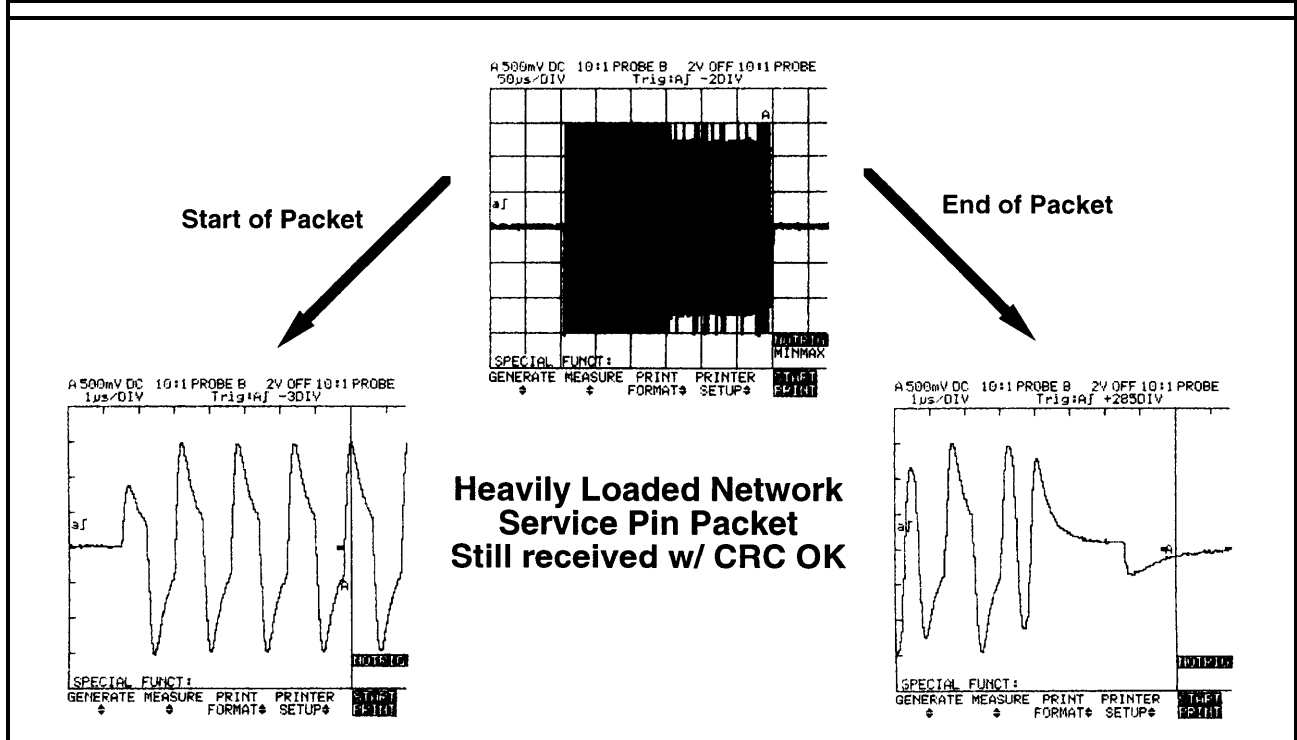
## [6.5.2] Typical TP/XF-1250 Analog Network Waveforms

- TP/XF-1250 networks must be wired in **Doubly-Terminated Bus topology**.
- See the TPT User's Guide<sup>6</sup> for detailed information.

<b>SYMPTOM</b>	<b>POSSIBLE CAUSE</b>
<p>A device cannot communicate on a TP/XF-1250 network.</p>	<ul style="list-style-type: none"> <li>• Use the right-hand side of the Troubleshooting Flowchart shown in [2.] to help in debugging this device's comm problem. First double-check that the wire, connections and termination are correct. Then use Service Pin presses to generate transmit packets, so that the CP line waveforms can be checked [6.1.1]. Another device on the network can be used to generate incoming traffic to the device under test in order to check the CP line waveforms in receive mode. Finally, the analog waveforms on the network can be checked for clues about the lost communication.</li> </ul>
<p>A device can communicate on a small network, but not on a large, heavily loaded network.</p>	<ul style="list-style-type: none"> <li>• Suspect the presence of extra capacitance in the transceiver area, or noise sources on the PC board. Check to be sure that no extra capacitance has been added to the network connection for the device (such as extra transient protection devices like zener diodes). Check also that the PC board layout for the CP lines is low-capacitance (short traces without an adjacent inner-layer ground plane under the traces). Look for noise sources in the 1.25Mbps communication band, like DC-DC converters. If a DC-DC converter is suspected of coupling noise into the transceiver transformer, try re-orienting or moving the inductor to see if communication integrity improves.</li> </ul>
